Highway Tree Management Tree Removal - Assessment and Consultation

Street Name: Bridgeman Street, Walsall	Tree Location/address: Outside F. Martin & Son – Tree 1
Date: 02.01.2025	Assessment Officer(s): Glyn Wilkes (Arboriculture Surveyor)

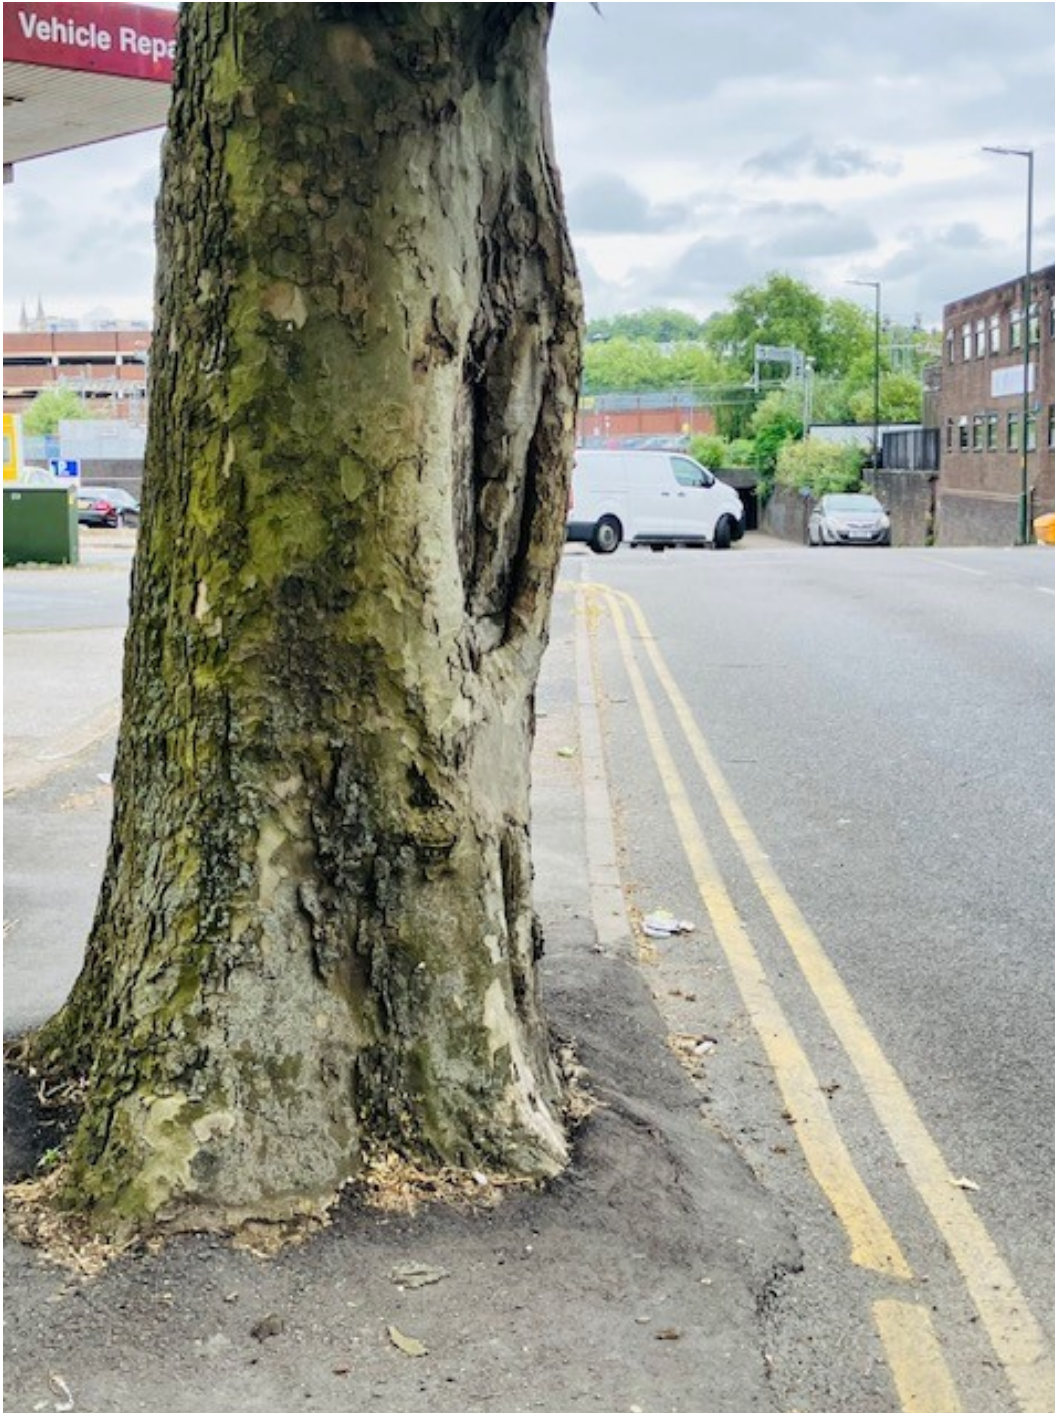
Location e.g. School, surgery, other facility	Unclassified Road / Bus Route / Local Distributor Rd. Between Augustus St and Navigation Street.
Minimum Footway Width 1.0m in accordance with DfT guidance 'Inclusive Mobility' Section 3.1	Footway width narrows to 0.8m which makes it impassable for mobility scooters and wheelchairs.
Maximum Footway Gradient 1:10 in accordance DfT guidance 'Inclusive Mobility' Section 3.2 Review footway crossfall for wheelchairs and mobility scooters.	Minor gradient change on footway.
Exposed Tree Roots assess for trip hazards and structural damage to adjacent property	Trial pit excavated adjacent to property; roots present. Root analysis confirms Acer spp.
Tree Root Heave Lifting carriageway surface and creating standing water with increased risk of sheet ice during winter periods.	Tree root heave is primarily affecting footway.
Kerbs Displaced into Carriageway by Tree Roots. Assess risk to motor vehicles and potential to cause road traffic accidents.	Minor kerb displacement.

Item	Details
1	Photo attached - Along length of footway
2	Photo attached – Base of tree
3	
4	
5	
6	
7

<p>Alternative Engineering Solutions Available to Retain Tree</p>	<p>Engineering solutions have been considered but site constraints make this an impractical option.</p>
<p>Replacement & Replanting Proposal</p>	<p>The Highway Authority will fund the cost of two replacement trees in a suitable local location determined by the Council's Arboricultural Officer. Species of new trees will be determined.</p>
<p>Recommended Course of Action by Highway Authority</p> <p>Retain tree <input type="checkbox"/></p> <p>Remedial work <input type="checkbox"/></p> <p>Remove tree X</p>	<p>A decision has been made to remove this tree. Investigations have proven that the tree roots are causing property damage</p>
<p>Signature Glyn Wilkes</p>	<p style="text-align: right;">Date: 02.01.2025</p>
<p>Signature (Highway Inspector)</p>	<p style="text-align: right;">Date:</p>
