Highway Tree Management Tree Removal - Assessment and Consultation

Street Name: Ryle Street, Walsall	Tree Location/address: Opposite house number 1B
Date:	Assessment Officer(s):
13.01.2025	Richard Pohribnyj (Highway Asset Manager)
	Glyn Wilkes (Arboriculture Surveyor)

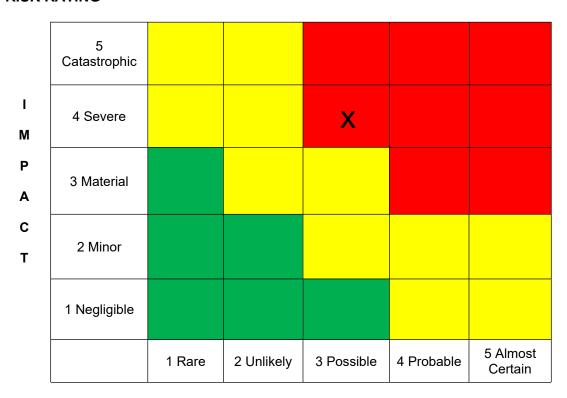
RISK RATING

Impact Risk Score assessed as 4 multiplied by Likelihood Risk Score assessed as 3 Overall risk rating is 12 and is classified as a High Risk

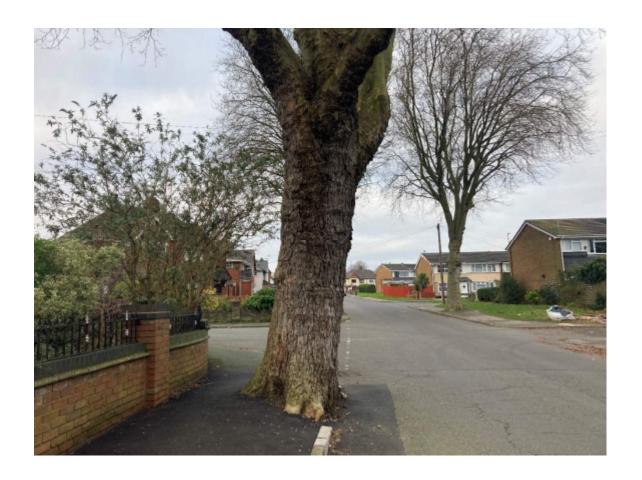
Location e.g. School, surgery, other facility	Unclassified Road / Residential Street/Link Road Between Valley Rd and Field Rd
Minimum Footway Width 1.0m in accordance with DfT guidance 'Inclusive Mobility' Section 3.1	Footway width narrows to 0.9m, therefore the footway width does not comply with 'Inclusive Mobility Section 3.1
Maximum Footway Gradient 1:10 in accordance DfT guidance 'Inclusive Mobility' Section 3.2 Review footway crossfall for wheelchairs and mobility scooters.	Footway gradient is reasonable for mobility scooters and wheelchair users, but this is purely academic because the footway width may prove too narrow for some users to get between the tree and back of path.
Exposed Tree Roots assess for trip hazards and structural damage to adjacent property	Minimal risk
Tree Root Heave Lifting carriageway surface and creating standing water with increased risk of sheet ice during winter periods.	Minimal risk

Item	Details
1	Photo attached - Along length of footway
2	Photo attached – Base of tree
3	Photo attached - Looking towards tree from carriageway
4	
5	
6	
7

Alternative Engineering Solutions Available to Retain Tree	site constraints make this an impractical option.
Replacement & Replanting Proposal	The Highway Authority will fund the cost of two replacement trees in a suitable local location determined by the Council's Arboricultural Officer. Species of new trees will be London Plane
Recommended Course of Action by Highway Authority Retain tree	A joint decision has been made to remove this tree in order to provide access along the footway for pushchairs, mobility scooters and wheelchair users.
Remedial work	
Remove tree X	
Signature Glyn Wilkes(Tree Inspector)	Date: 13.01.2025
Signature Richard Pohribnyj(Highway Inspector)	Date: 13.01.2025

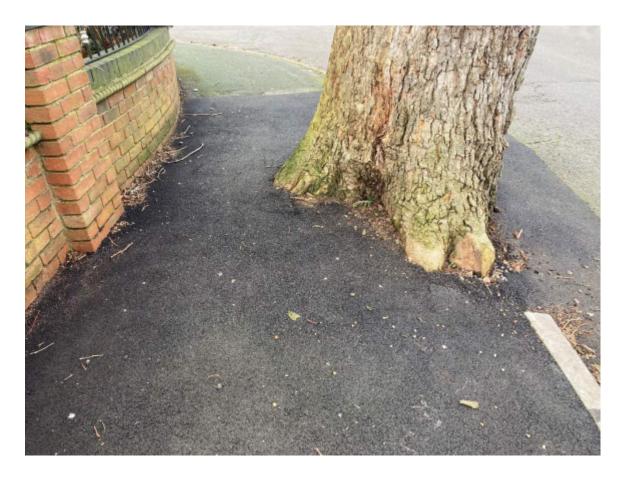
Kerbs Displaced into Carriageway by Tree Roots. Assess risk to motor vehicles and potential to cause road traffic accidents.	Highway kerbs have been removed due to encroachment of tree
Overhanging Highway Creating a danger to high sided vehicles. Recommend that trees do not overhang the highway kerb line for a height of 2.5m, increasing to 4.5m on bus routes. (Highways Act S154)	The trunk of the tree is overhanging the highway and poses an unacceptable risk to high sided vehicles
Potential Risk and Insurance Claims Risk level, previous claims.	None.
