Highway Tree Management Tree Removal - Assessment and Consultation

| Street Name: New Road | Tree Location/address: Left hand side of 'The Castle' Public House. |
| Date: 09/06/25 | Assessment Officer(s): Eden Turley Jag Raan |

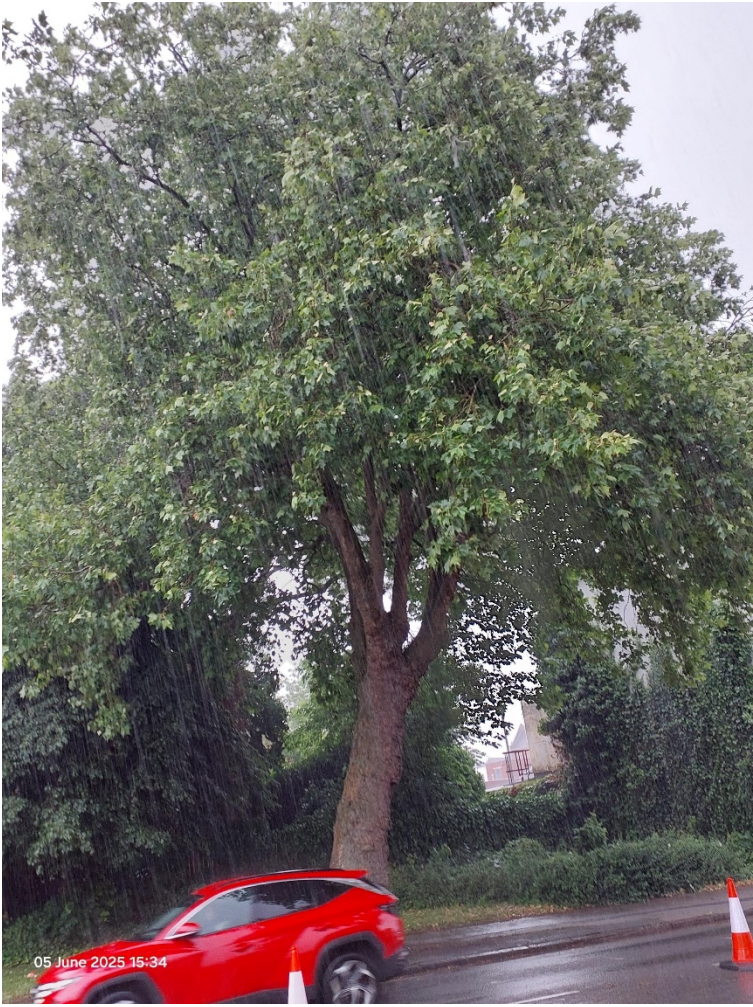
| Item | Details |
|---|---|
| 1 | Photo attached – Side profile of Tree Full View |

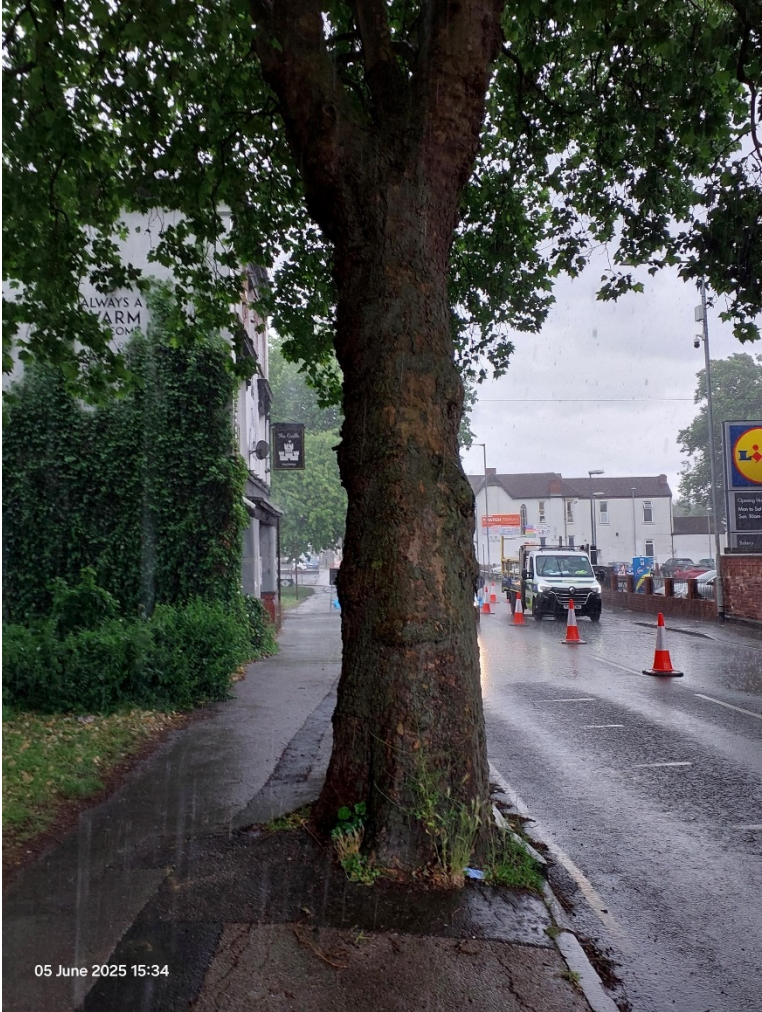
| Tree Root Heave Lifting carriageway surface and creating standing water with increased risk of sheet ice during winter periods. | Existing footway heave significant moderate risk |
| Kerbs Displaced into Carriageway by Tree Roots. Assess risk to motor vehicles and potential to cause road traffic accidents. | Minor displacement of kerbs is present. |

| Item | Details |
|---|---|
| 2 | Photo attached – Base of tree looking East |

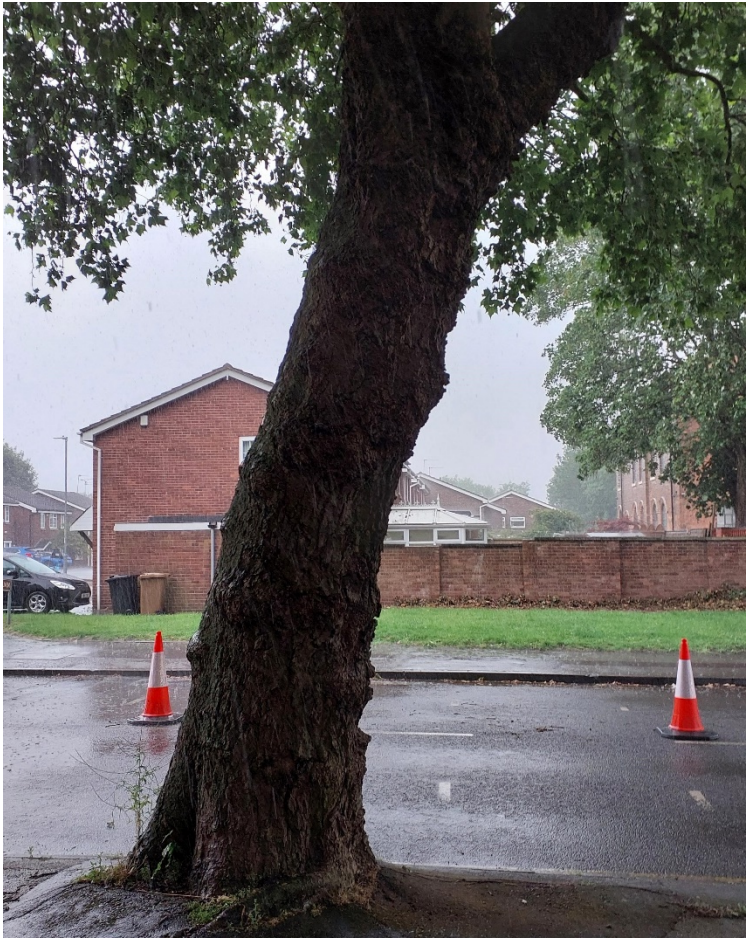
| Potential Risk and Insurance Claims Risk level, previous claims. | We are on site now with ATF4, the current plan is to have a cycle junction here for the combined crossing. The tree obscures the visibility for both pedestrians crossing the cycleway and cyclists joining the route from the southern side of New Road. |

| Item | Details |
|---|---|
| 3 | Photo attached – Looking towards tree from back of footpath |

| Recommended Course of Action by Highway Authority Retain tree <input type="checkbox"/> Remedial work <input type="checkbox"/> Remove tree <input checked="" type="checkbox"/> | A decision has been made to remove this tree. The tree serves a potential risk as per guidance in LTN 1/20 Chapter 5. |
