Highway Tree Management Tree Removal - Assessment and Consultation

Street Name: Walsall Road, Willenhall	Tree Location/address: Outside property number 160
Date: 15.03.24	Assessment Officer(s): Richard Pohribnyj (Highway Asset Manager) Glyn Wilkes (Arboriculture Surveyor)

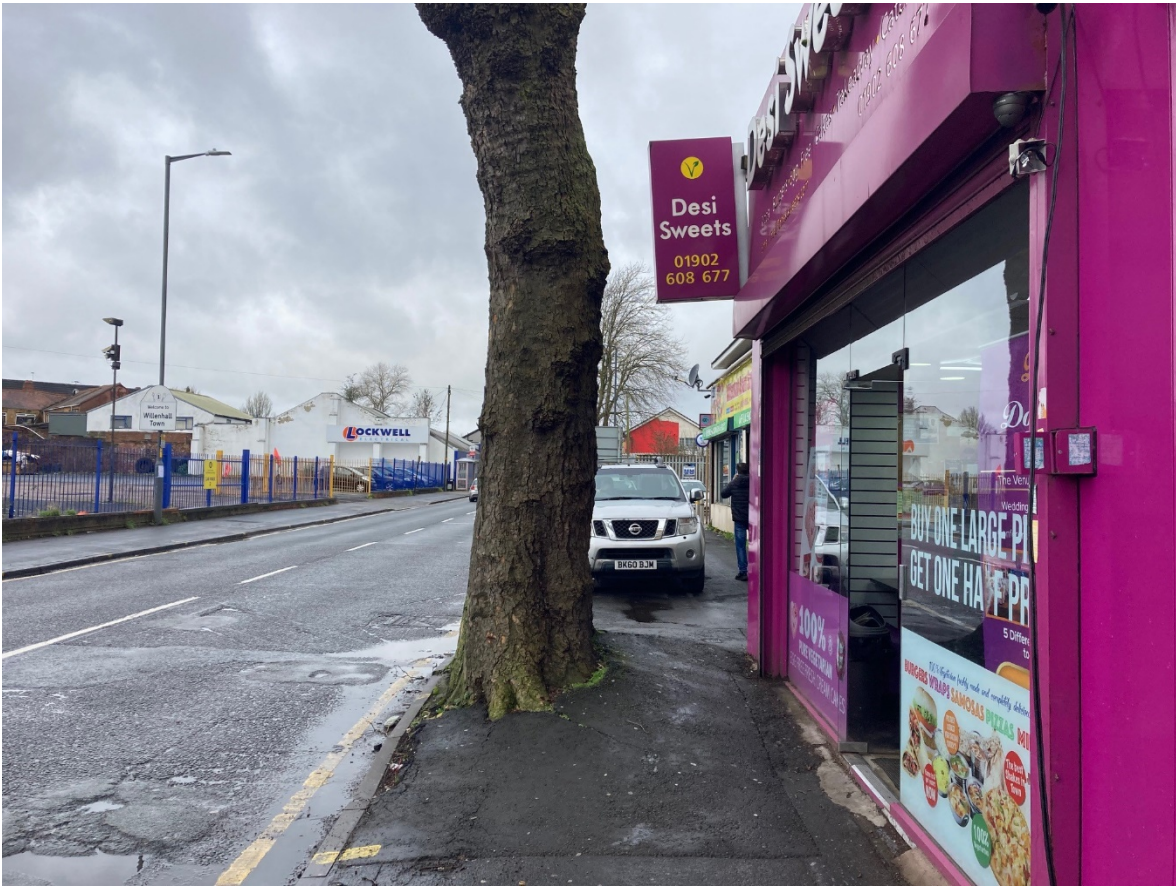
Item	Details
1	Photo attached - Along length of footway
2	Photo attached – Base of tree
3	Photo attached - Looking towards tree from carriageway
4	
5	
6	
7
