Highway Tree Management Tree Removal - Assessment and Consultation

Street Name: Grange Street, Walsall	Tree Location/address: Opposite property number 2
Date: 17.09.2024	Assessment Officer(s): Glyn Wilkes (Arboriculture Surveyor)

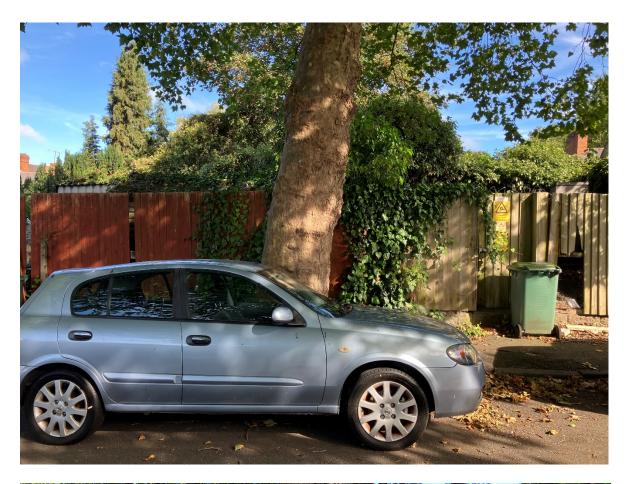
Location e.g. School, surgery, other facility	Unclassified Road. Between Sandwell Street and Hawes Road
Minimum Footway Width 1.0m in accordance with DfT guidance 'Inclusive Mobility' Section 3.1	Footway width is reduced to 0.5m which makes it impassable for mobility scooters and wheelchairs
Maximum Footway Gradient 1:10 in accordance DfT guidance 'Inclusive Mobility' Section 3.2 Review footway crossfall for wheelchairs and mobility scooters.	Footway gradient adversely affected
Exposed Tree Roots assess for trip hazards and structural damage to adjacent property	No risk
Tree Root Heave Lifting carriageway surface and creating standing water with increased risk of sheet ice during winter periods.	Tree root heave is lifting the footway surface, kerbs and carriageway
Kerbs Displaced into Carriageway by Tree Roots. Assess risk to motor vehicles and potential to cause road traffic accidents.	Kerbs have been displaced

Item	Details
1	Photo attached - Looking towards tree from carriageway
2	Photo attached - Along length of footway
3	Photo attached – Base of tree
4	
5	
6	
7

Replacement & Replanting Proposal	The Highway Authority will fund the cost of a replacement tree in a suitable local location determined by the Council's Arboriculture Officer. Species of new tree is yet to be determined.
Recommended Course of Action by Highway Authority	A decision has been made to remove this tree on highway safety grounds
Retain tree	
Remedial work	
Remove tree X	
Tree Inspection G Wilkes – Arboriculture Surveyor	Date: 17.09.2024
