Highway Tree Management Tree Removal - Assessment and Consultation

Street Name: Grange Street, Walsall	Tree Location/address: Side of property number 91 West Bromwich Road
Date: 17.09.2024	Assessment Officer(s): Glyn Wilkes (Arboriculture Surveyor)

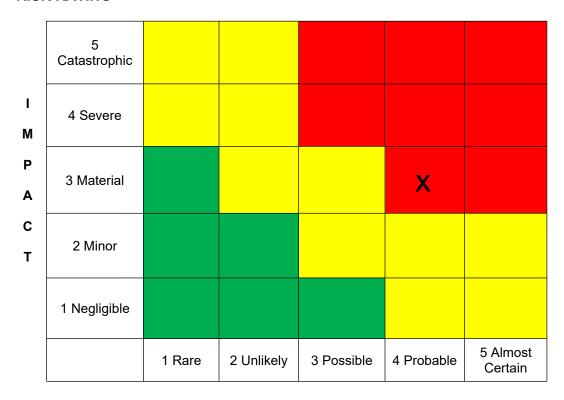
RISK RATING

Impact Risk Score assessed as 3 multiplied by Likelihood Risk Score assessed as 4 Overall risk rating is 12 and is classified as a High Risk

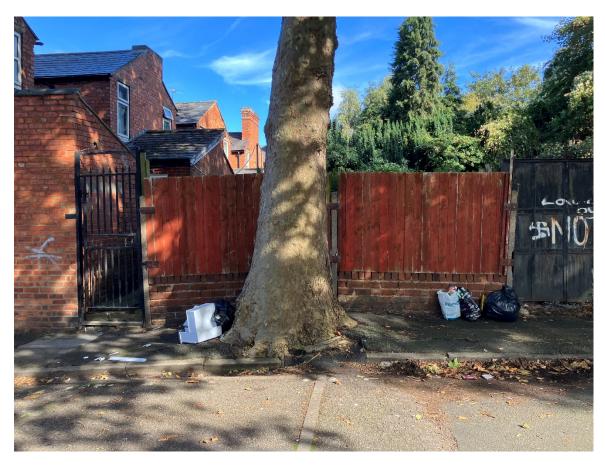
Location e.g. School, surgery, other facility	Unclassified Road. Between Sandwell Street and Hawes Road
Minimum Footway Width 1.0m in accordance with DfT guidance 'Inclusive Mobility' Section 3.1	Footway width is reduced to 0.6m which makes it impassable for mobility scooters and wheelchairs
Maximum Footway Gradient 1:10 in accordance DfT guidance 'Inclusive Mobility' Section 3.2 Review footway crossfall for wheelchairs and mobility scooters.	Footway gradient adversely affected
Exposed Tree Roots assess for trip hazards and structural damage to adjacent property	No risk
Tree Root Heave Lifting carriageway surface and creating standing water with increased risk of sheet ice during winter periods.	Tree root heave is lifting the footway surface and causing cracking
Kerbs Displaced into Carriageway by Tree Roots. Assess risk to motor vehicles and potential to cause road traffic accidents.	Kerbs have been displaced

Item	Details
1	Photo attached - Looking towards tree from carriageway
2	Photo attached - Along length of footway
3	Photo attached – Base of tree
4	
5	
6	
7

Replacement & Replanting Proposal	The Highway Authority will fund the cost of a replacement tree in a suitable local location determined by the Council's Arboriculture Officer. Species of new tree is yet to be determined.
Recommended Course of Action by Highway Authority	A decision has been made to remove this tree on highway safety grounds
Retain tree	
Remedial work	
Remove tree X	
Tree Inspection G Wilkes – Arboriculture Surveyor	Date: 17.09.2024
