## Highway Tree Management Tree Removal - Assessment and Consultation

<b>Street Name:</b> Bridgeman Street, Walsall	<b>Tree Location/address:</b> Outside F Martin and Son – Tree 2
<b>Date:</b> 02.01.2025	<b>Assessment Officer(s):</b> Glyn Wilkes (Arboriculture Surveyor)

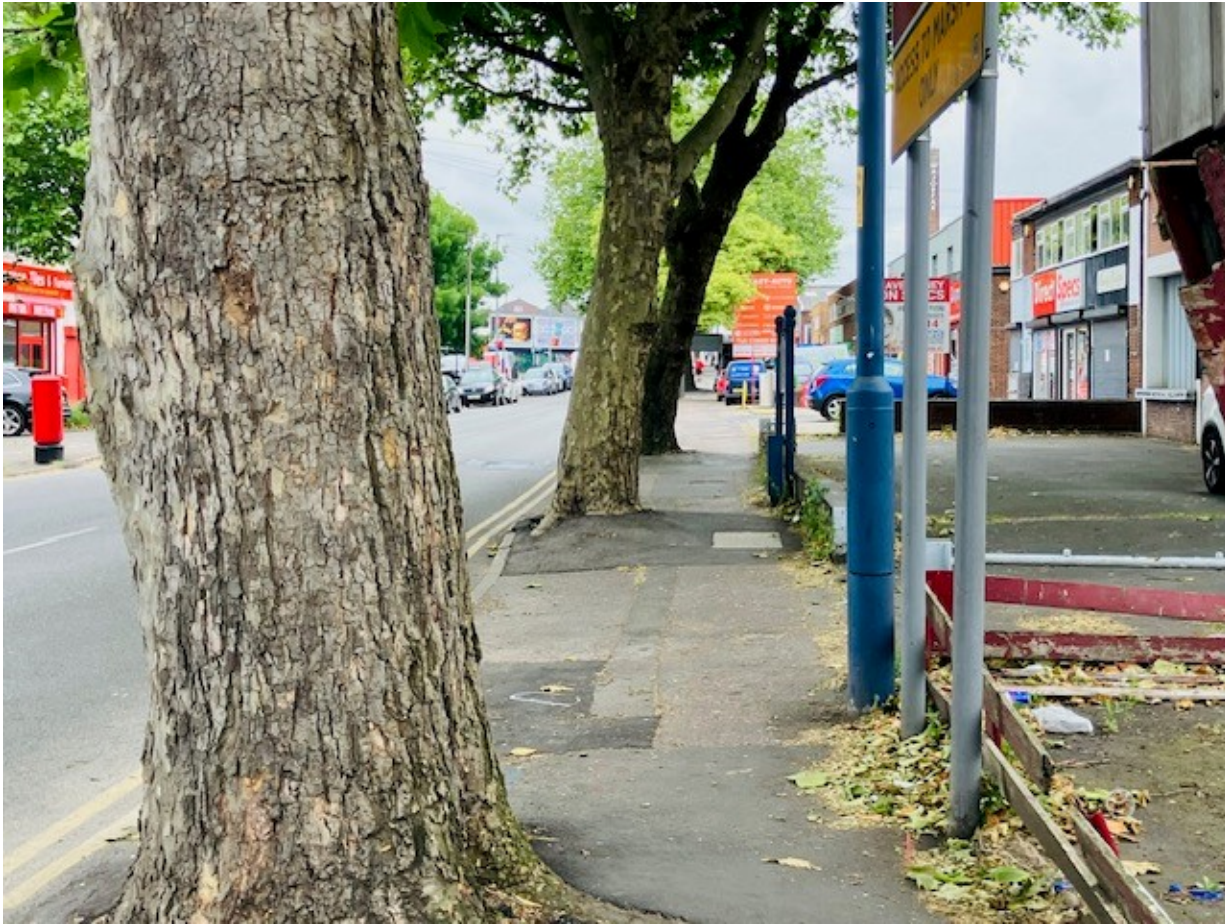
Item	Details
1	Photo attached - Along length of footway
2	
3	
4	
5	
6	
7

<b>Location</b> e.g. School, surgery, other facility	Unclassified Road / Bus Route / Local Distributor Rd. Between Augustus St and Navigation St
<b>Minimum Footway Width</b> 1.0m in accordance with DfT guidance 'Inclusive Mobility' Section 3.1	Footway width narrows to 0.8m which makes it impassable for mobility scooters and wheelchairs.
<b>Maximum Footway Gradient</b> 1:10 in accordance DfT guidance 'Inclusive Mobility' Section 3.2 Review footway crossfall for wheelchairs and mobility scooters.	Minor gradient change on footway.
<b>Exposed Tree Roots</b> assess for trip hazards and structural damage to adjacent property	Main root is exposed in footway and restricting available width.
<b>Tree Root Heave</b> Lifting carriageway surface and creating standing water with increased risk of sheet ice during winter periods.	Tree root heave is primarily affecting footway.
<b>Kerbs Displaced into Carriageway by Tree Roots.</b> Assess risk to motor vehicles and potential to cause road traffic accidents.	Minor kerb displacement.

<p><b>On-going Maintenance Costs</b> e.g. Highway Repair</p>	<p>Have previously patched the footway, minor kerb displacement observed, but no major on-going maintenance implications</p>
<p><b>Species and Value</b> Capital Asset Value for Amenity Trees (CAVAT)</p>	<p>London Plane (Platanus x acerifolia) CAVAT value £16,164.00</p>
<p><b>Condition &amp; Health of Tree</b> Safe Useful Life Expectancy (SULE)</p>	<p>SULE 60 - 80 years</p>
<p><b>Community/ Consultation</b> (Duty to Consult on Felling Trees)</p>	<p>This tree assessment has been carried out following concerns raised by a local resident.</p> <p>A public consultation period will be open for 28 days. The consultation period will end on 10<sup>th</sup> February 2025. Should you choose to comment during this period, please email <a href="mailto:cleanandgreen@walsall.gov.uk">cleanandgreen@walsall.gov.uk</a></p> <p>You will need to provide details of the tree location together with your comments.</p> <p>Also include a note in your email that it is for the attention of the Arboriculture Team.</p>

<p><b>Alternative Engineering Solutions Available to Retain Tree</b></p>	<p>Engineering solutions have been considered but site constraints make this an impractical option.</p>
<p><b>Replacement &amp; Replanting Proposal</b></p>	<p>The Highway Authority will fund the cost of two replacement trees in a suitable local location determined by the Council's Arboricultural Officer. Species of new trees will be determined.</p>
<p><b>Recommended Course of Action by Highway Authority</b></p> <p>Retain tree <input type="checkbox"/></p> <p>Remedial work <input type="checkbox"/></p> <p>Remove tree <input checked="" type="checkbox"/></p>	<p>A decision has been made to remove this tree. Investigations have proven that the tree roots are causing property damage</p>
<p><b>Signature</b> Glyn Wilkes</p>	<p><b>Date:</b> 02.01.2025</p>
<p><b>Signature</b> (Highway Inspector)</p>	<p><b>Date:</b></p>
