Highway Tree Management Tree Removal - Assessment and Consultation

Street Name:	Tree Location/address:
Greaves Avenue, Walsall	Outside property number 47
Date: 31.12.2024	Assessment Officer(s): Glyn Wilkes (Arboriculture Surveyor)

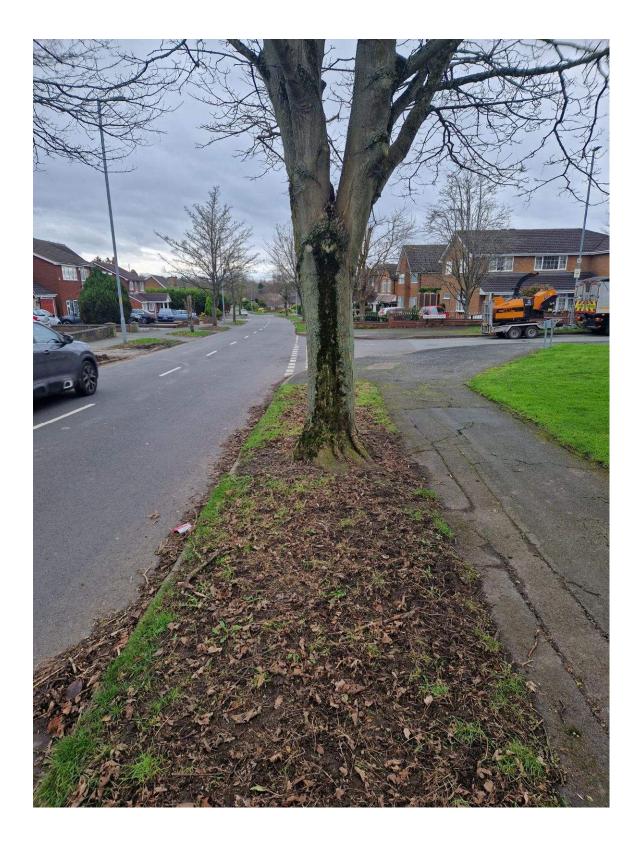
Item	Details	
1	Photo attached - Along length of footway	
2	Photo attached – Base of tree	
3		
4		
5		
6		
7

Alternative Engineering Solutions Available to Retain Tree	Engineering solutions have been considered but no practical solution is available.
Replacement & Replanting Proposal	The Highway Authority will fund the cost of two replacement trees in a suitable local location determined by the Council's Arboriculture Officer. Species of new trees are yet to be determined.
Recommended Course of Action by Highway Authority	A decision has been made to remove this tree. Investigations have proven that the tree roots are causing property damage.
Retain tree	
Remedial work	
Remove tree X	
Tree Inspection G Wilkes – Arboriculture Surveyor	Date: 31.12.2024
