Highway Tree Management Tree Removal - Assessment and Consultation

Street Name: Trees Road	Tree Location/address: Outside house number 36
Date: 20.03.2025	Assessment Officer(s): Richard Pohribnyj (Highway Asset Manager) Glyn Wilkes (Arboriculture Surveyor)

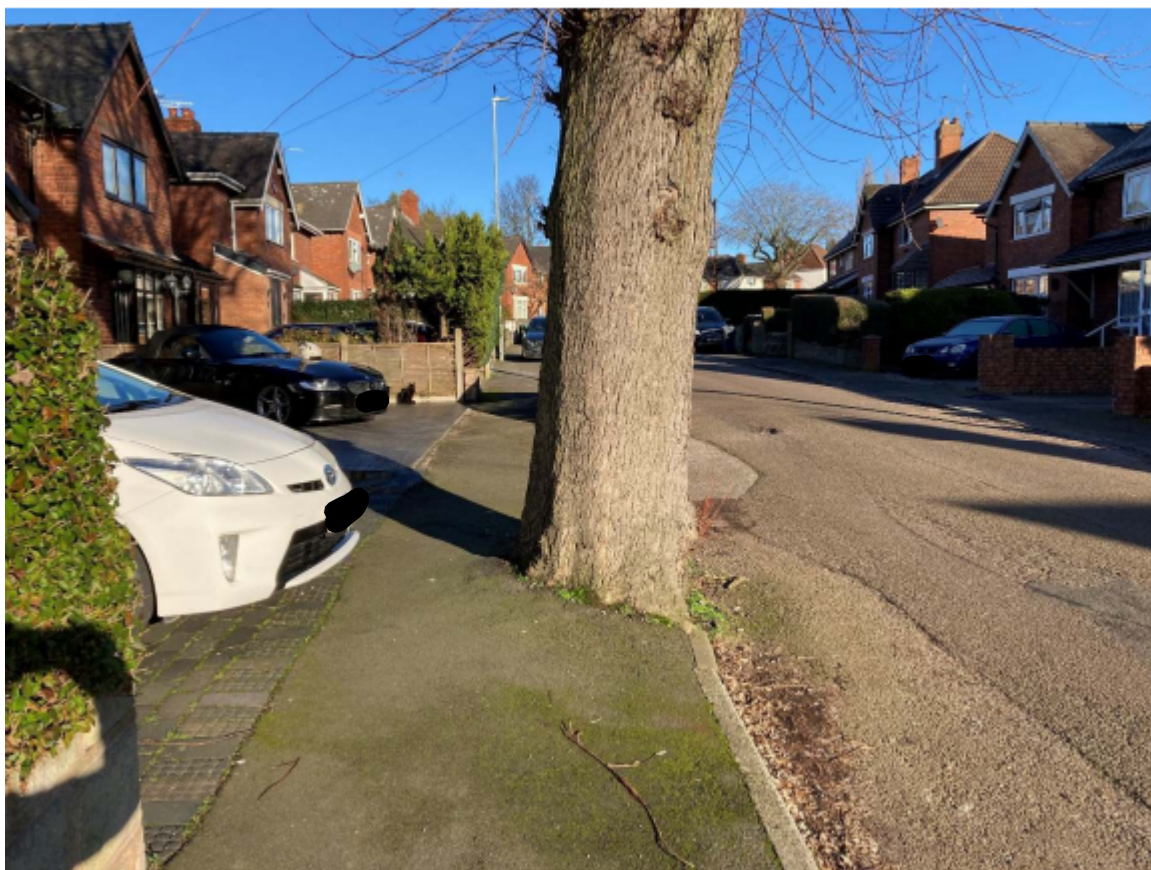
Location e.g. School, surgery, other facility	Unclassified Road / Residential Street
Minimum Footway Width 1.0m in accordance with DfT guidance 'Inclusive Mobility' Section 3.1	Footway width narrows to 0.9m which makes it impassable for mobility scooters and wheelchairs.
Maximum Footway Gradient 1:10 in accordance DfT guidance 'Inclusive Mobility' Section 3.2 Review footway crossfall for wheelchairs and mobility scooters.	Minimum risk.
Exposed Tree Roots assess for trip hazards and structural damage to adjacent property	No Risk.
Tree Root Heave Lifting carriageway surface and creating standing water with increased risk of sheet ice during winter periods.	No Risk.
Kerbs Displaced into Carriageway by Tree Roots. Assess risk to motor vehicles and potential to cause road traffic accidents.	Minor displacement of kerbs is present. A section of kerb has been removed to mitigate any risk.
Overhanging Highway Creating a danger to high sided vehicles. Recommend that trees do not overhang the highway kerb line for a height of 2.5m, increasing to 4.5m on bus routes. (Highways Act S154)	Very minor overhang. No risk.

Item	Details
1	Photo attached - Along length of footway
2	Photo attached – Base of tree
3	Photo attached – Looking towards tree from carriageway
4	
5	
6	
7

Alternative Engineering Solutions Available to Retain Tree	Engineering solutions have been considered but site constraints make this an impractical option.
Replacement & Replanting Proposal	The Highway Authority will fund the cost of two replacement trees in a suitable local location determined by the Council's Arboricultural Officer. Species of new trees will be determined.
Recommended Course of Action by Highway Authority Retain tree <input type="checkbox"/> Remedial work <input type="checkbox"/> Remove tree <input checked="" type="checkbox"/>	A decision has been made to remove this tree. The tree is restricting the footway width, so it does not comply with "Inclusive Mobility Section 3.1
Signature Glyn Wilkes (Arboricultural Surveyor)	Date: 20.03.2025
Signature (Highway Inspector)	Date: 20.03.2025

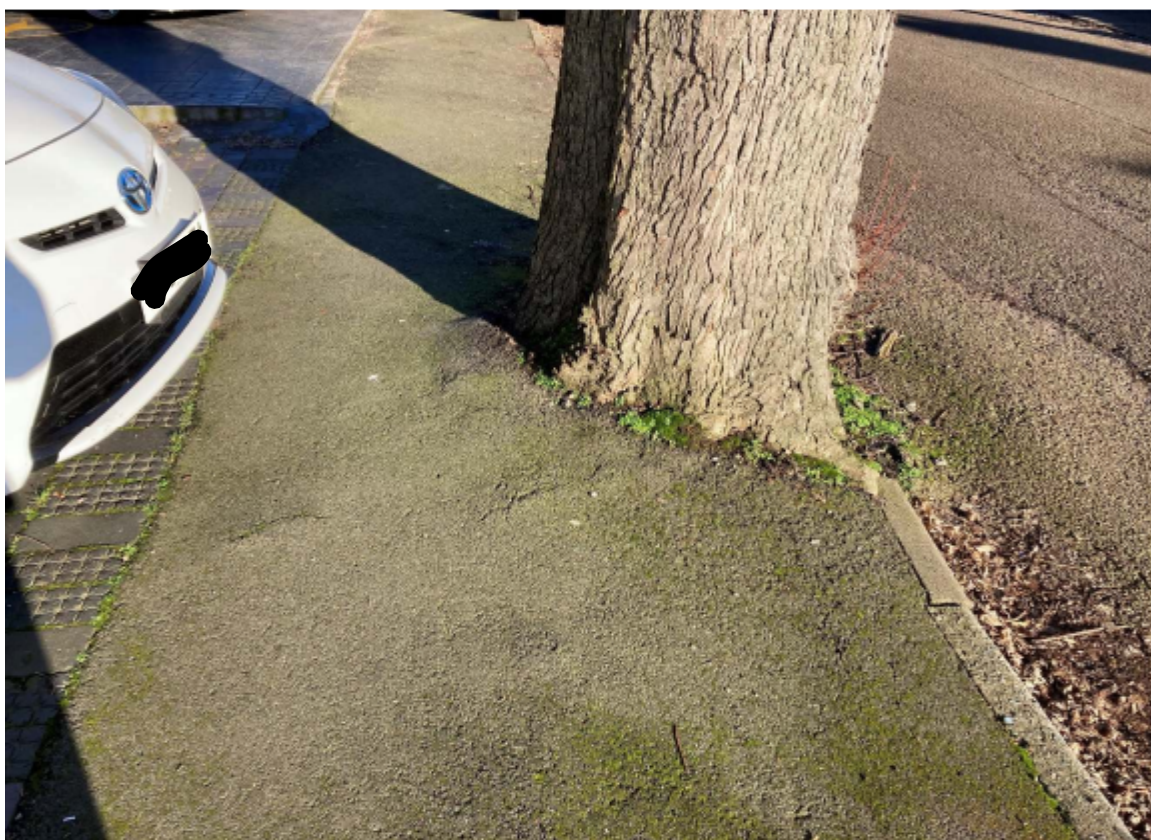
On-going Maintenance Costs e.g. Highway Repair	Have previously patched the footway, minor kerb displacement observed, but no major on-going maintenance implications
Species and Value Capital Asset Value for Amenity Trees (CAVAT)	Silver Maple (<i>Acer saccharinum</i>) CAVAT value £36,317.00
Condition & Health of Tree Safe Useful Life Expectancy (SULE)	SULE 20 - 60 years
Community/ Consultation (Duty to Consult on Felling Trees)	<p>This tree assessment has been carried out following concerns raised by a local resident.</p> <p>A public consultation period will be open for 28 days. The consultation period will end on 21st April 2025. Should you choose to comment during this period, please email cleanandgreen@walsall.gov.uk</p> <p>You will need to provide details of the tree location together with your comments.</p> <p>Also include a note in your email that it is for the attention of the Arboriculture Team.</p>
