Highway Tree Management Tree Removal - Assessment and Consultation

Street Name: Rosehill	Tree Location/address: Outside 109 Rosehill
Date: 10/06/25	Assessment Officer(s): Eden Turley Jag Raan

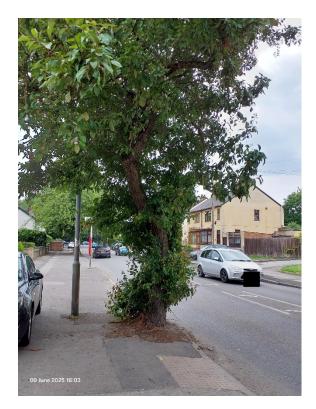
Item	Details
1	Photo attached – Side profile of Tree looking South
2	Photo attached – Base of tree looking West
3	Photo attached – Side profile of Tree looking North
4	Photo attached – Full View of Tree looking East
5	
6	
7

Recommended Course of Action by Highway Authority	A decision has been made to remove this tree. The tree serves a potential risk as per guidance in LTN 1/20 Chapter 5.
Retain tree	
Remedial work	
Remove tree X	
Signature	Date: 10.06.2025
Signature	Date: 11.06.2025
