Highway Tree Management Tree Removal - Assessment and Consultation

Street Name: Rosehill	Tree Location/address: Outside Number 99 Rosehill
Date: 10/06/25	Assessment Officer(s): Eden Turley Jag Raan

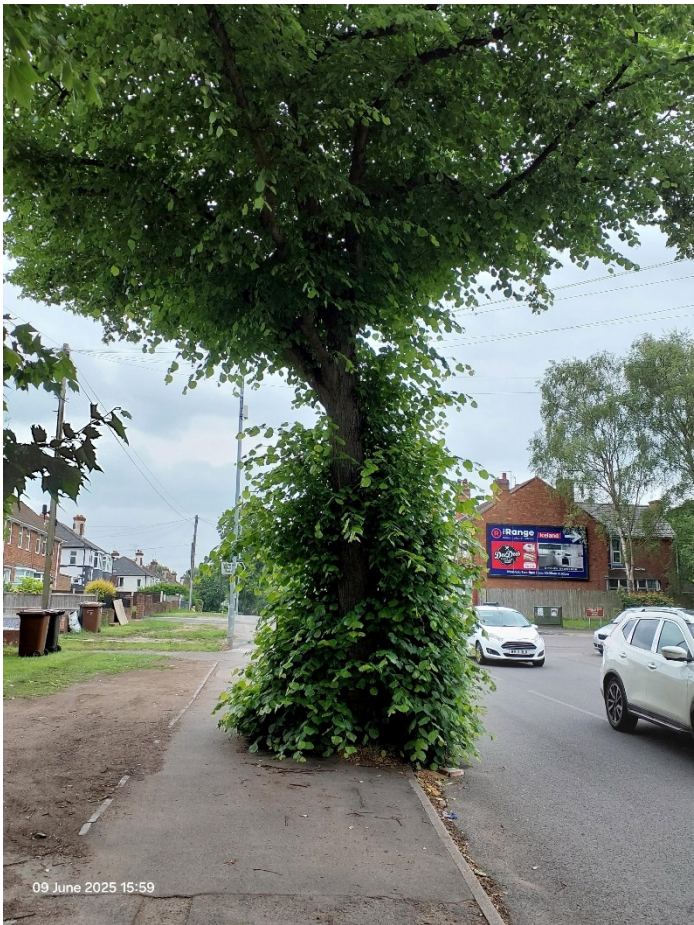
Item	Details
1	Photo attached – Side profile of Tree Looking South
2	Photo attached – Base of tree looking West
3	Photo attached – Side profile of Tree Looking North
4	Photo attached – Side elevation of Tree Looking East
5	
6	
7
